Cawsand Advanced Mooring Systems interim project results

Dr Jean-Luc Solandt, Principal Specialist, Marine Protected Areas,
Marine Conservation Society, UK

June 2022

Advanced Mooring System (AMS) ‘Stirling’ Design:

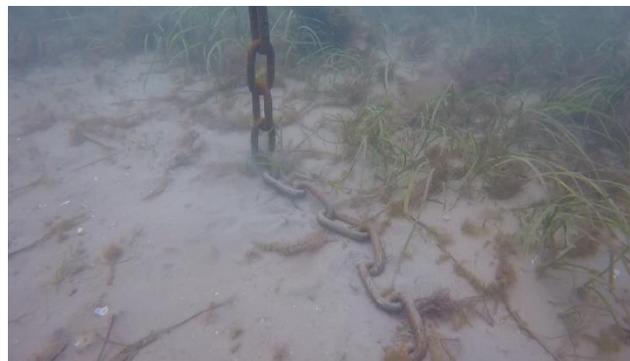
Figure 1: *Diagram of the design of the Stirling ‘Advanced Mooring System’.* (Source: Yachting Monthly) (Left). *Picture (right) of ‘traditional swing mooring’ chain abrasion of the seabed at Cawsand* (source: Ocean Conservation Trust).

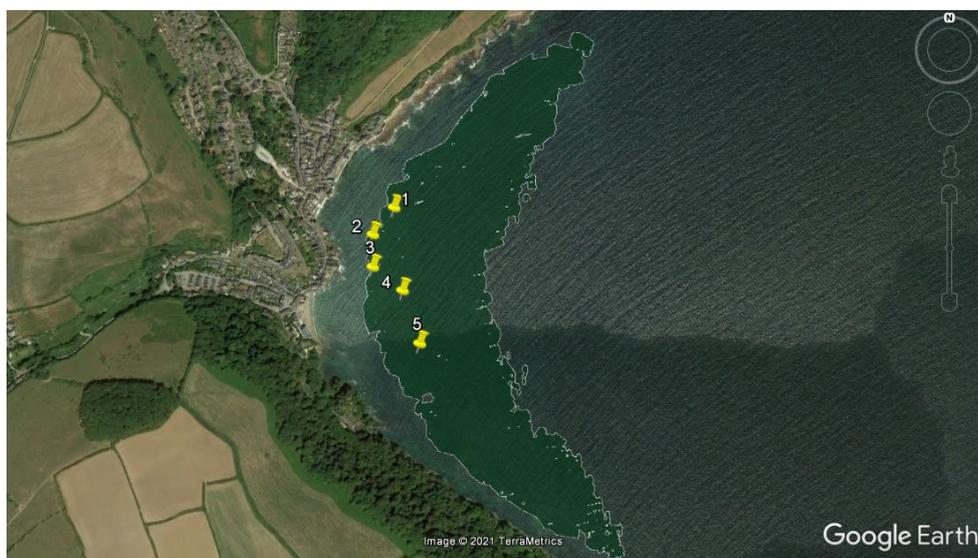
Figure 6: Location of the Advanced Moorings Systems studied in this project.

Moorings #3 & #4 are very much in line with the entry of the Cawsand Ferry to the beach (Fig. 6). As they are also in line with the beach where tenders make for shore from yachts, they are popular with recreational boating (Fig. 7). This may be affecting the ability of seagrass to re-establish around the new moorings that we have put in. At lowest low water, these moorings are in 2-3m of water, making any disturbance at the surface from propellers significant.

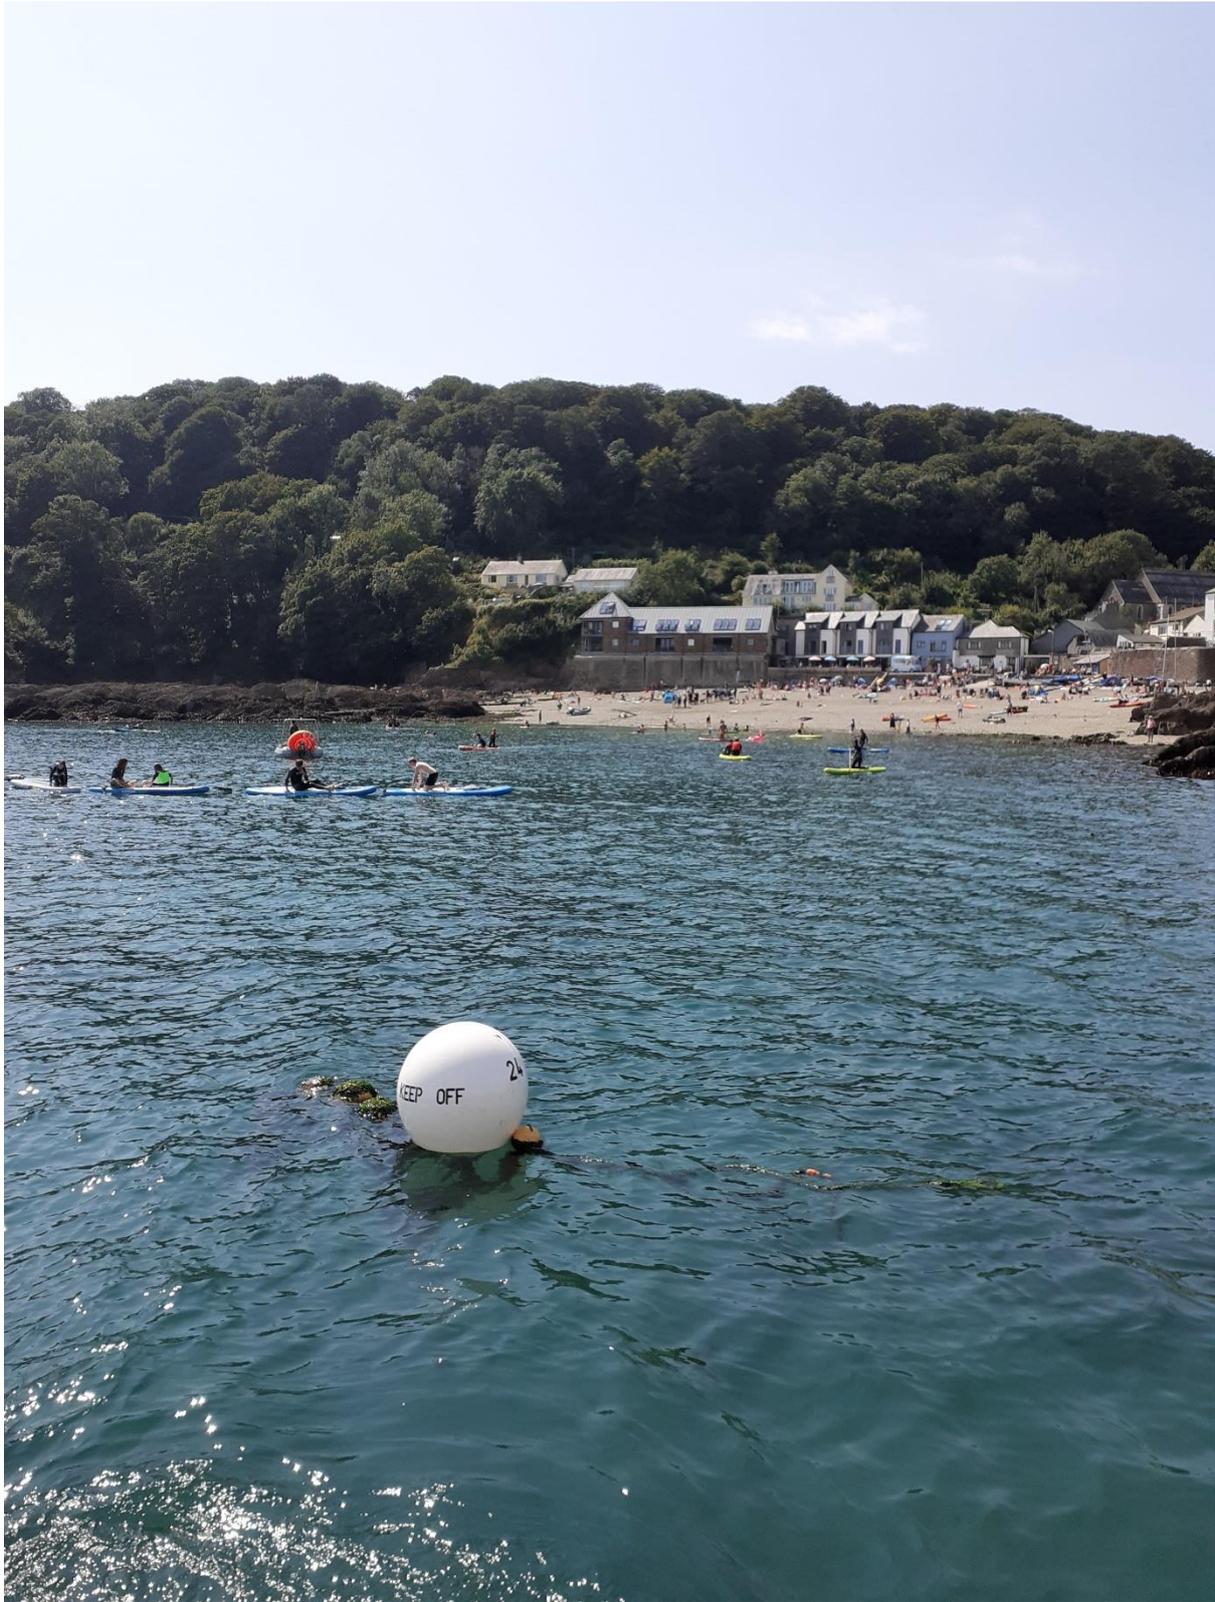
Figure 7: Paddleboards at Mooring #3 (marked on the buoy as '24') during the June 2021 survey.

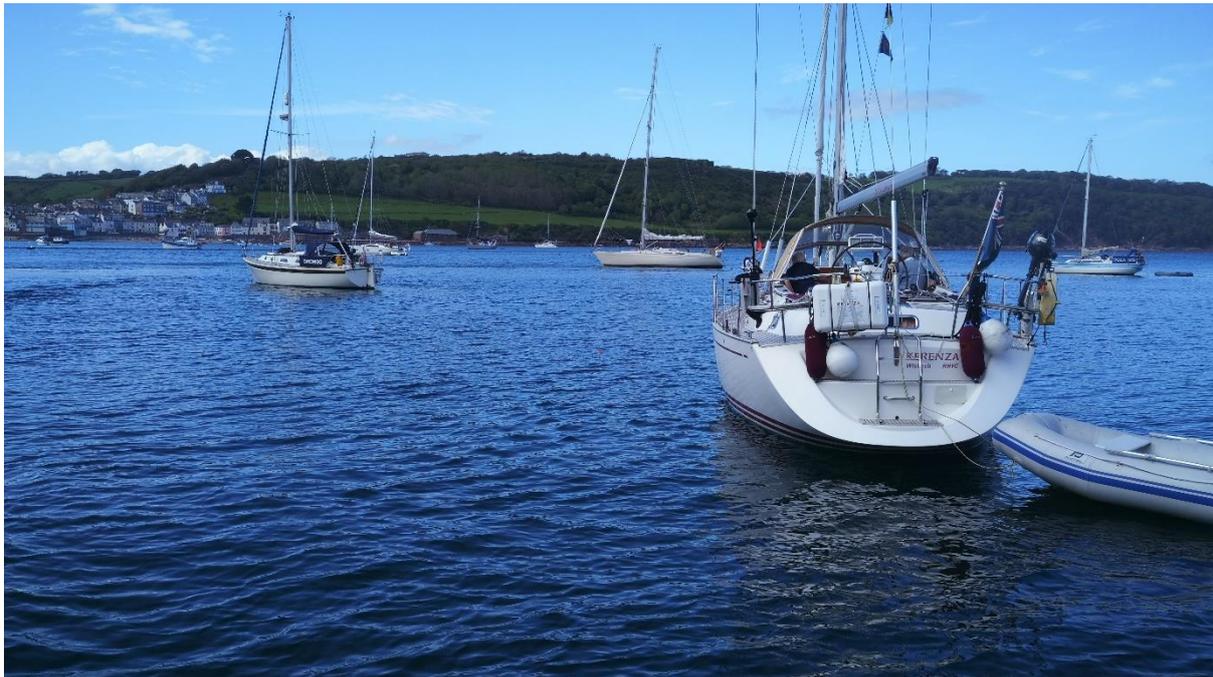
The author was actually hit by an anchor during the June 2021 survey. Fortunately, the anchor only passed by, without attaching to dive kit (hoses in particular), but it also passed very close to the mooring itself. This was fortuitous as the anchor actually made a course very close to one of the AMS

screwpile moorings, that increases the likelihood of snagging against the top of the screwpile, and thereby damaging the seagrass within the vicinity of the mooring.

Figure 8: June 2021 survey. Locals reported heavy boat use in summer holiday months, with up to 120 vessels counted using the sheltered seagrass-rich area for anchoring (photo by JL Solandt during June 2021 dive monitoring survey trip).

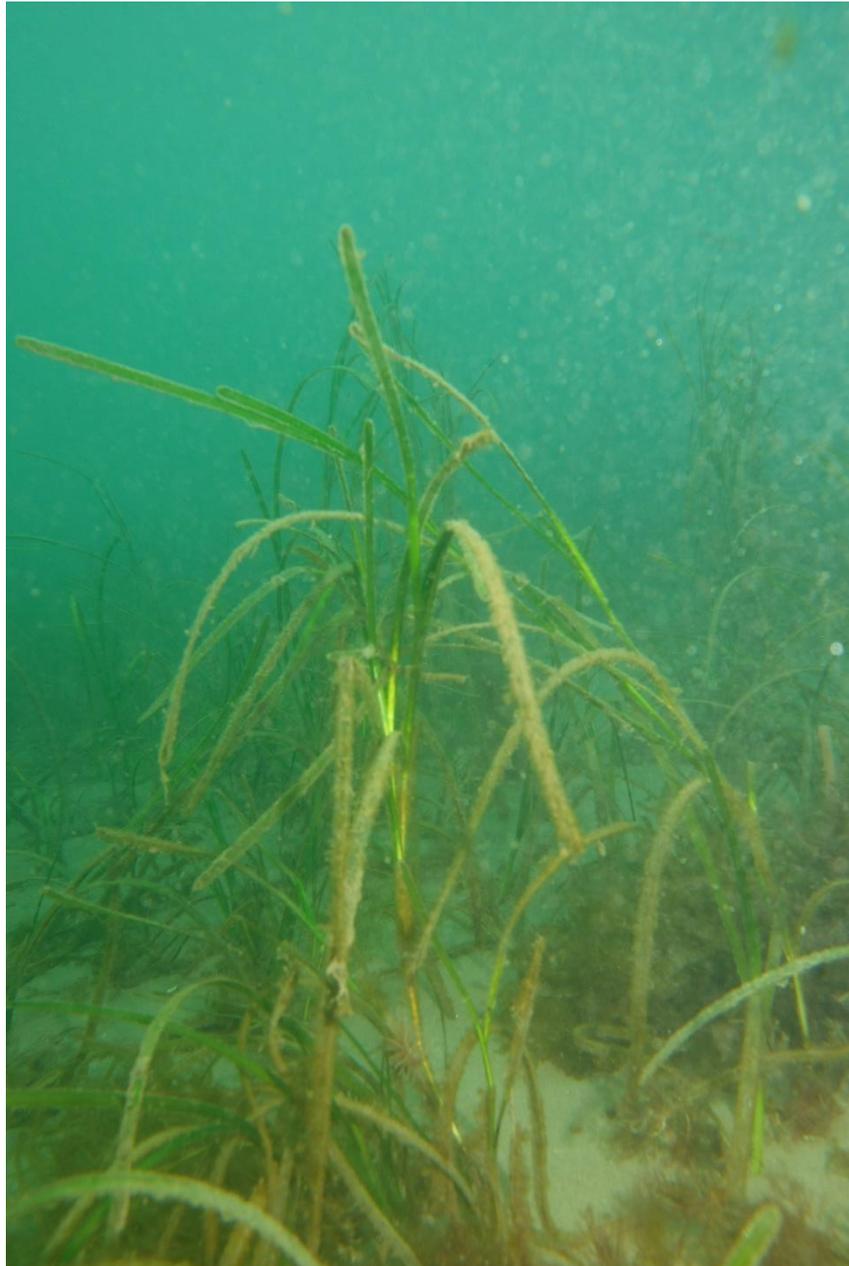
Figure 9: Image taken in June 2020 showing heavy sediment in the water column, and some epiphytisation of the seagrass blades.

Another environmental factor affecting the density of the beds is likely to be poor water quality. On some dives, the health of the beds appeared to be affected by heavy colonisation of epiphytes. Red algae was particularly abundant around the blades of mooring #1 in June 2021 (Fig 9). This was at a time of very heavy boat use within the sheltered bay.
